Inspection Report

Property Address:
1406 Ascent Trail
Huntsville AL 35816

McNeese Home Inspections

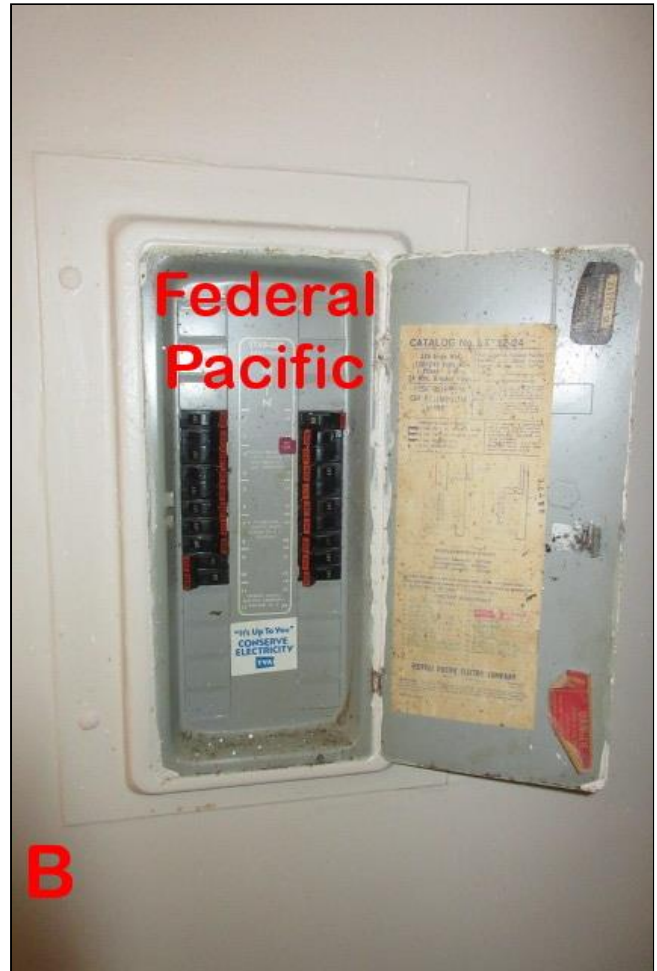
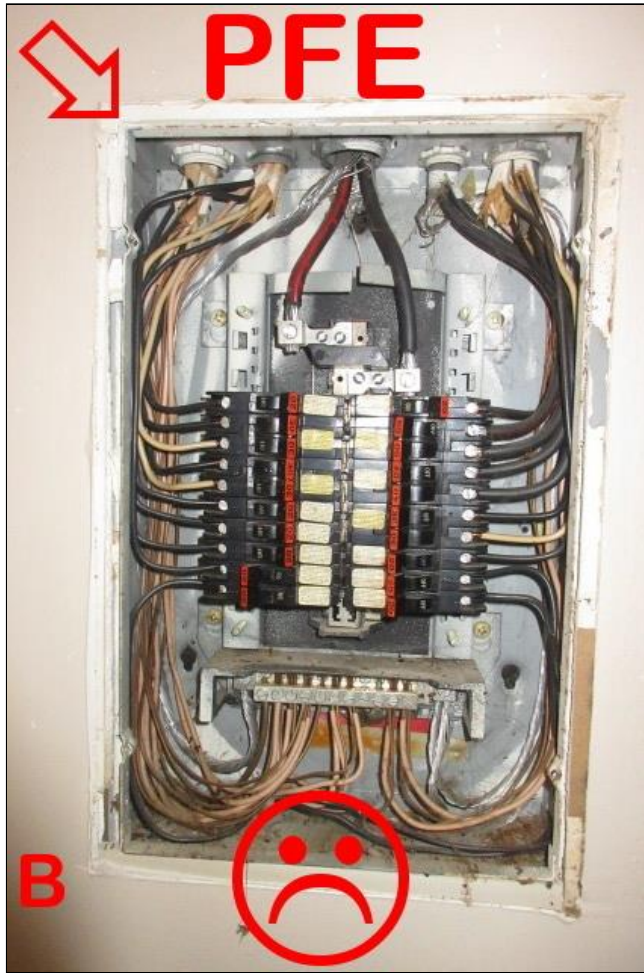
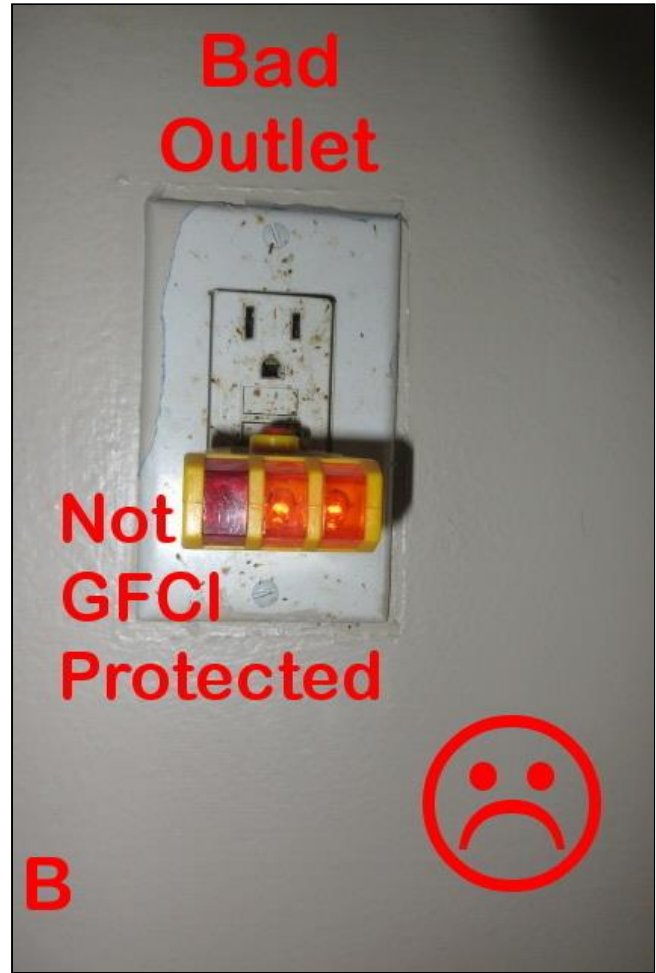
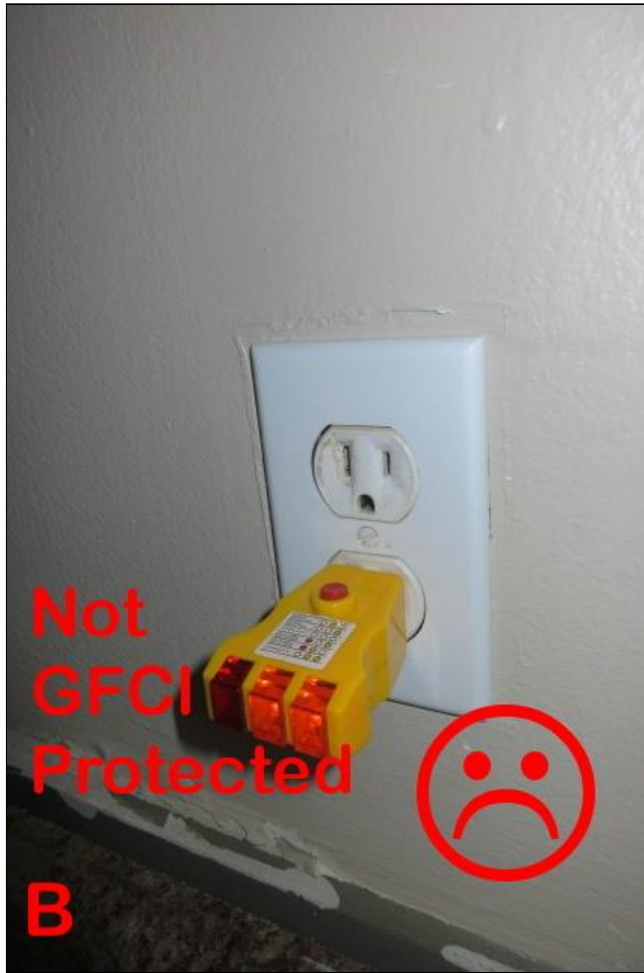
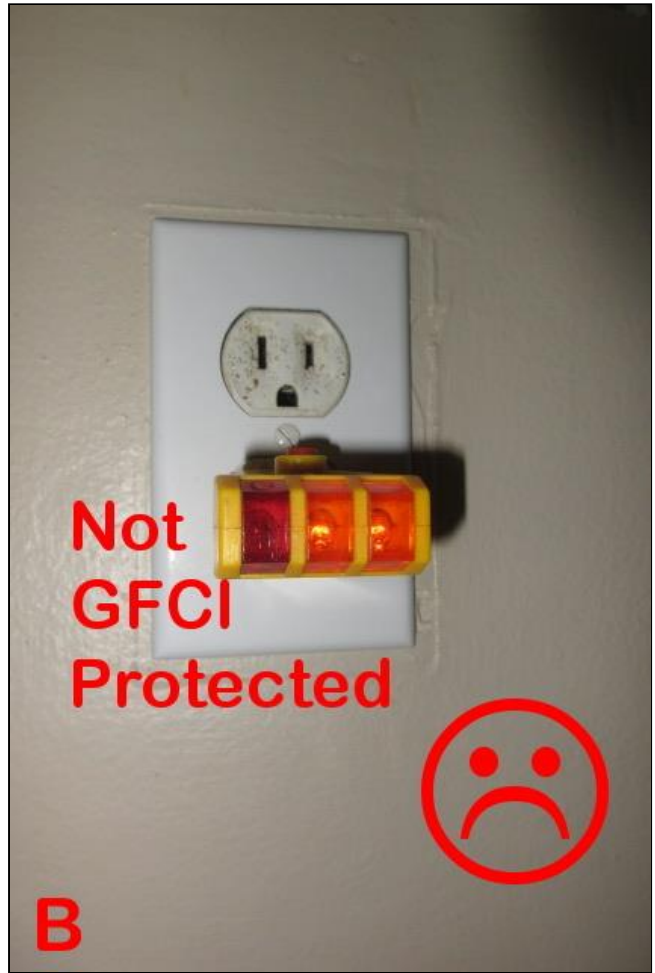
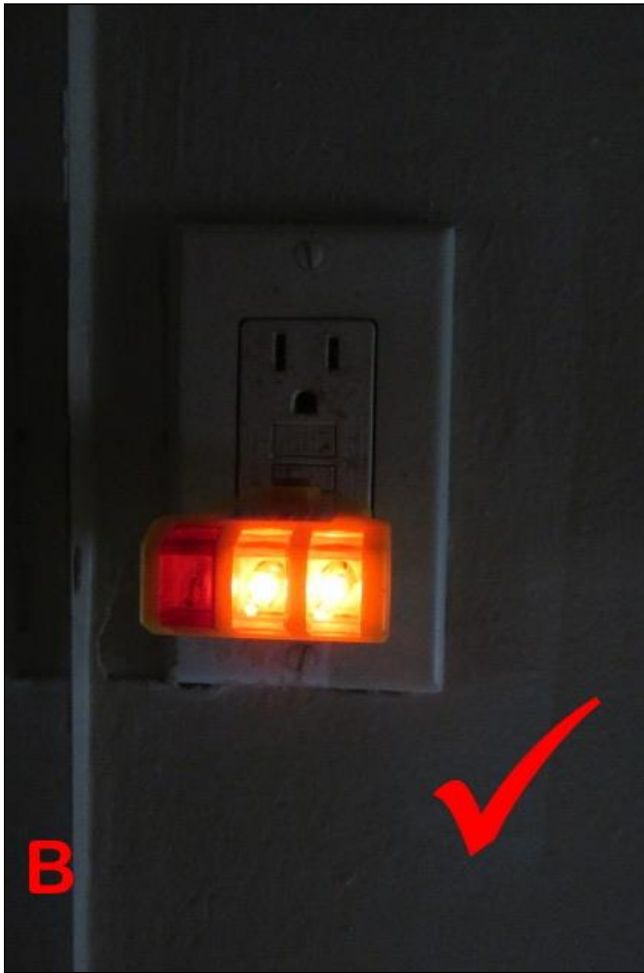
3.0 Item 1(Picture)

Electrical Service	Panel capacity:	Panel Type:
Conductors:	125 AMP	Circuit breakers
Below ground	Extra Info : 4 125's	
200 Amp Meter Base		
Electric Panel	Branch wire 15 and 20 AMP:	Wiring Methods:
Manufacturer:	Copper	Romex
FEDERAL PACIFIC		three wire system in branch
Underwriters Lab		wiring
Approved		
Location of Electrical	GFCI Safety Protection:	Safety Devices for Smoke or
Disconnect:	GFCI outlets are in place in the Kitchen, bathrooms,	Carbon Monoxide:
Inside on the Main	garage and exterior outlets as they should be	The Home is missing Smoke
Load Center	Kitchen outlets near water are protected	Detectors in one or more Bedrooms
	Bathroom outlets near water are protected	The Home is missing a Carbon
	Exterior outlets near water are protected	Monoxide Detector
	GFCI outlets are missing	
	Kitchen outlets should be GFCI protected and they	
	are not	
	Bath outlets should be GFCI protected and they are	
	not

6. Romex connector is missing at the power source on the water heater in unit C. This is an issue and it needs to be corrected.
7. The GFCI outlet in unit A is bad and needs to be replaced. This is an issue and it needs to be corrected.

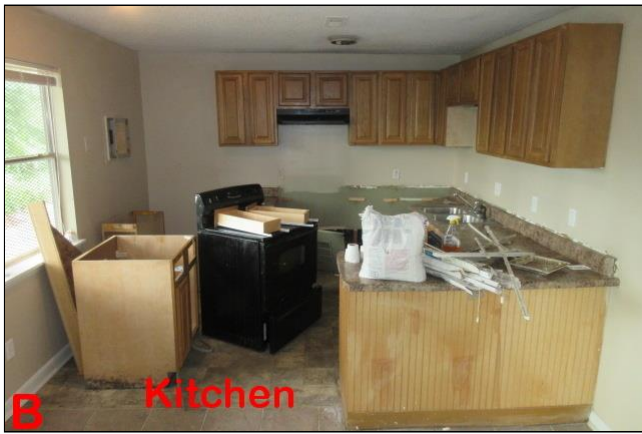
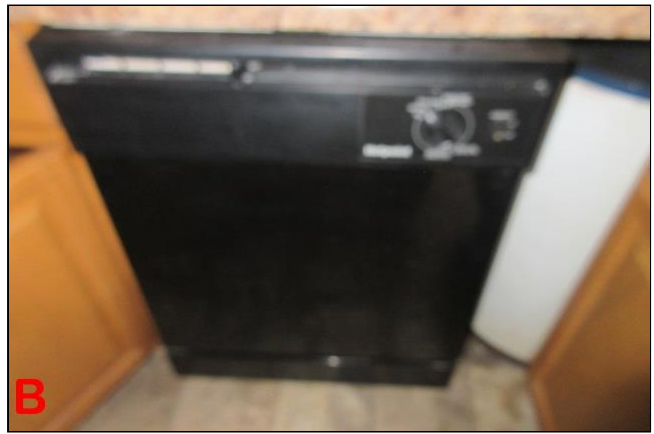
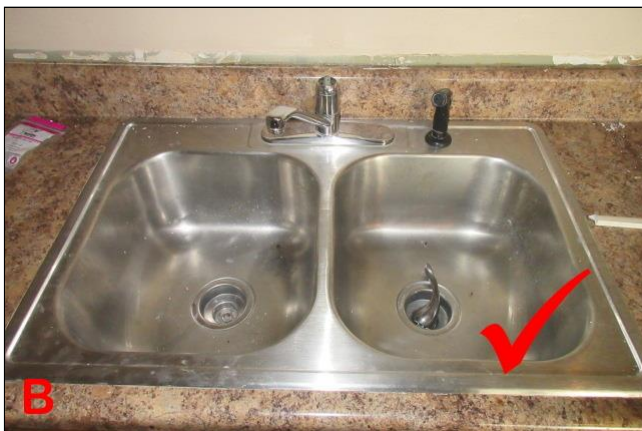
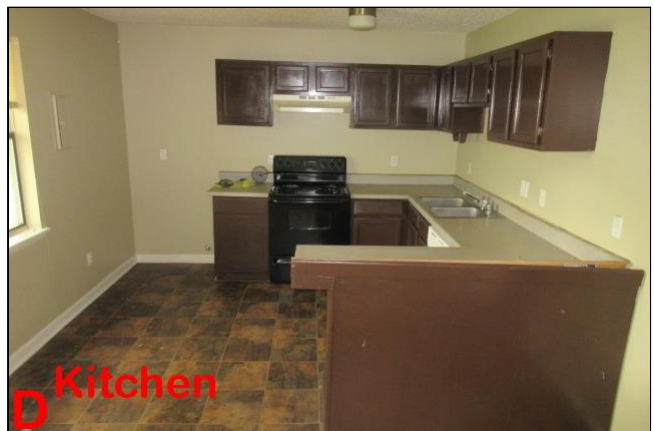
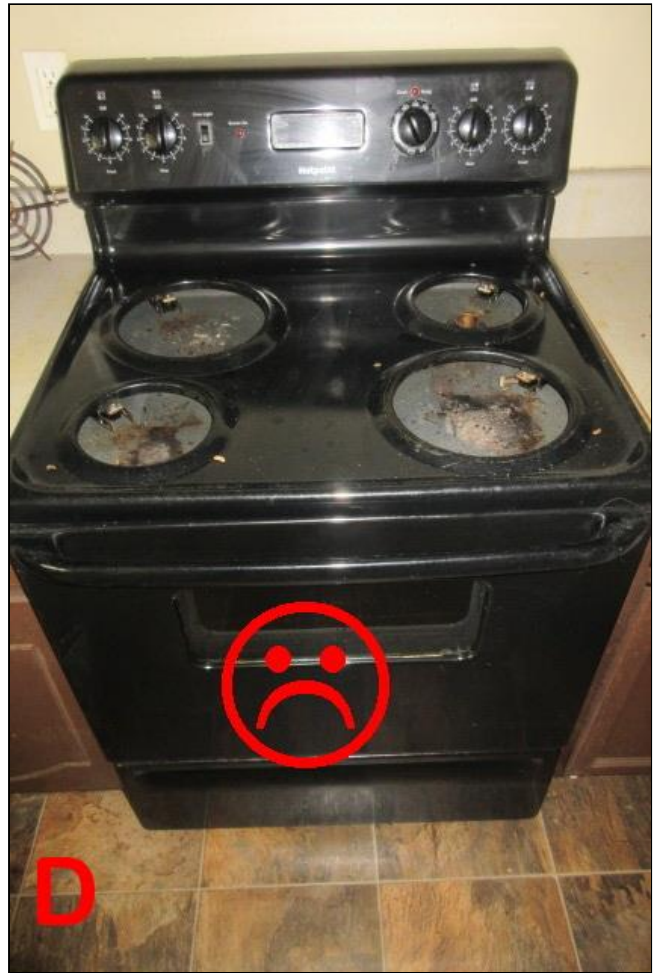
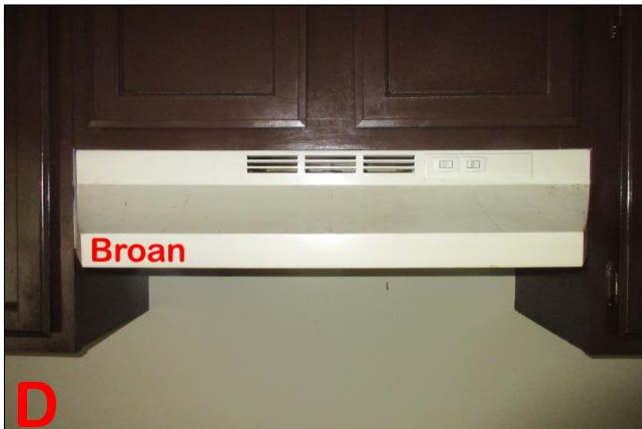
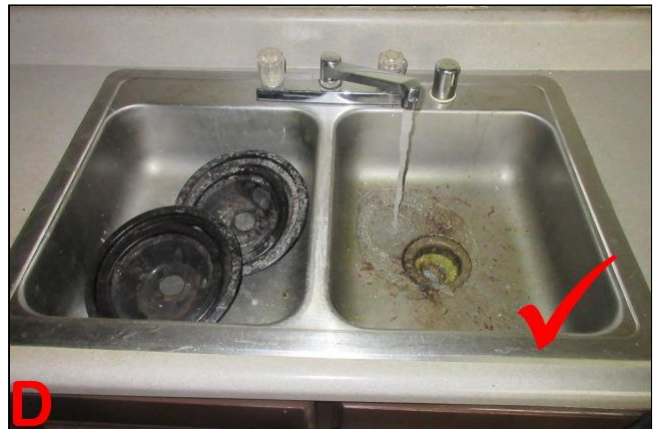
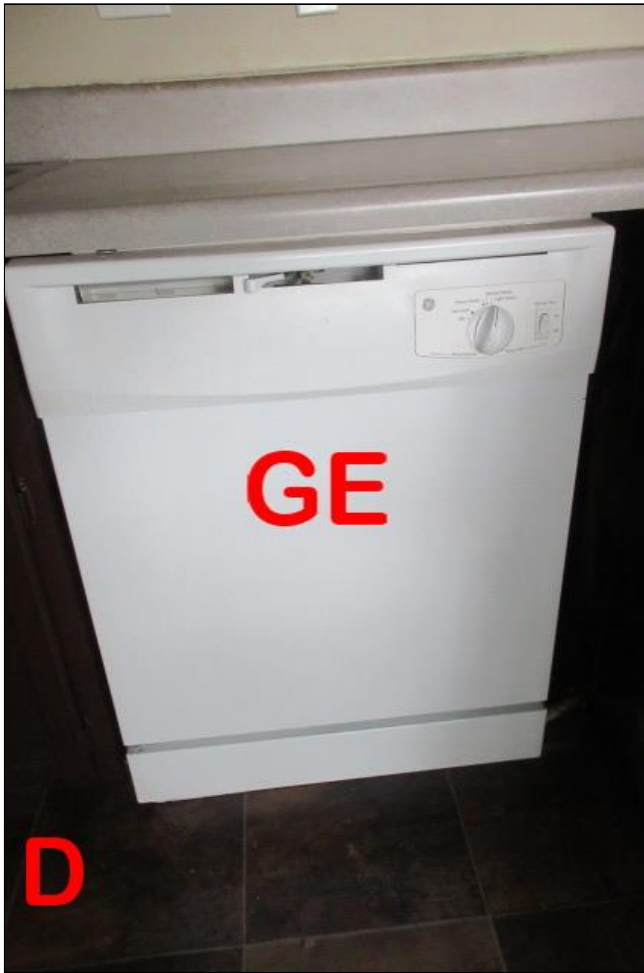
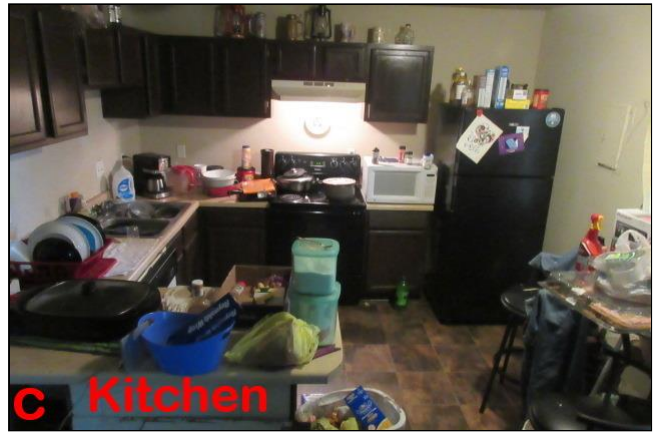
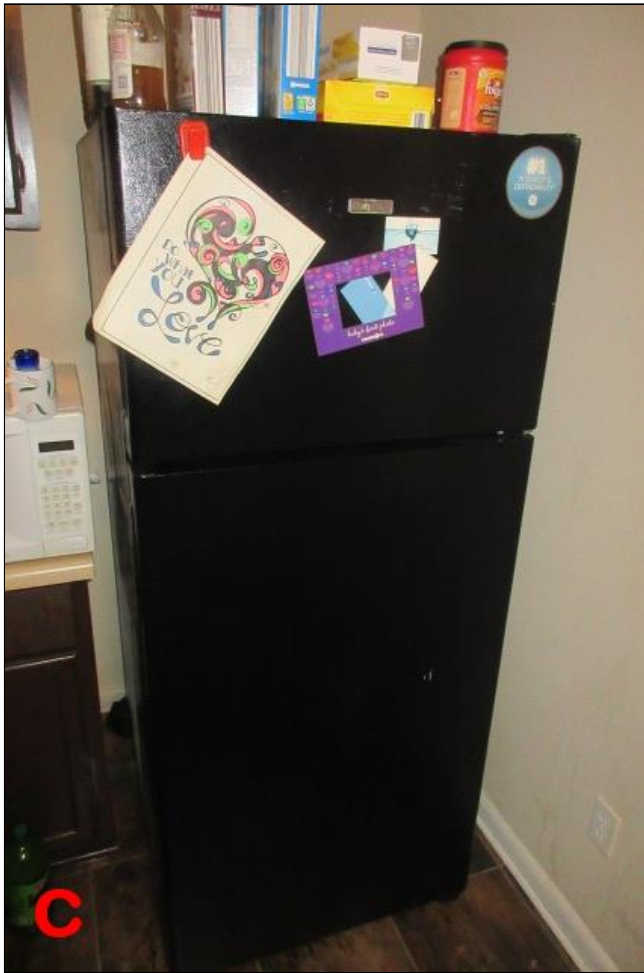
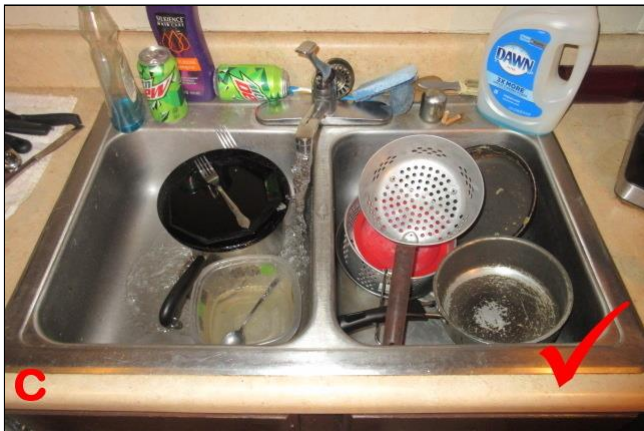
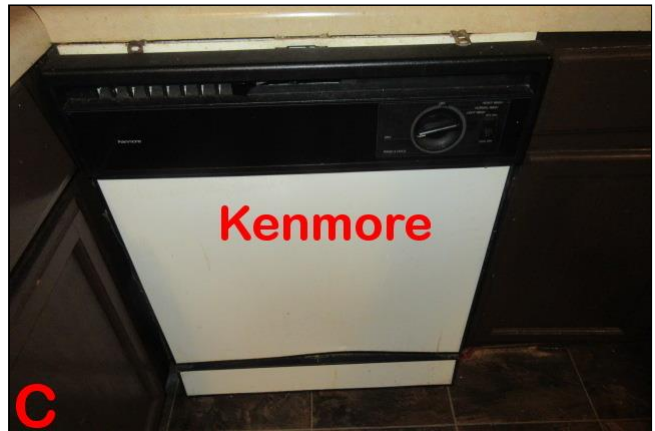
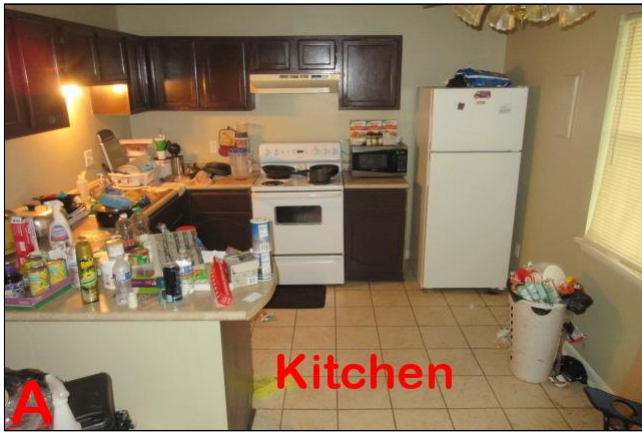
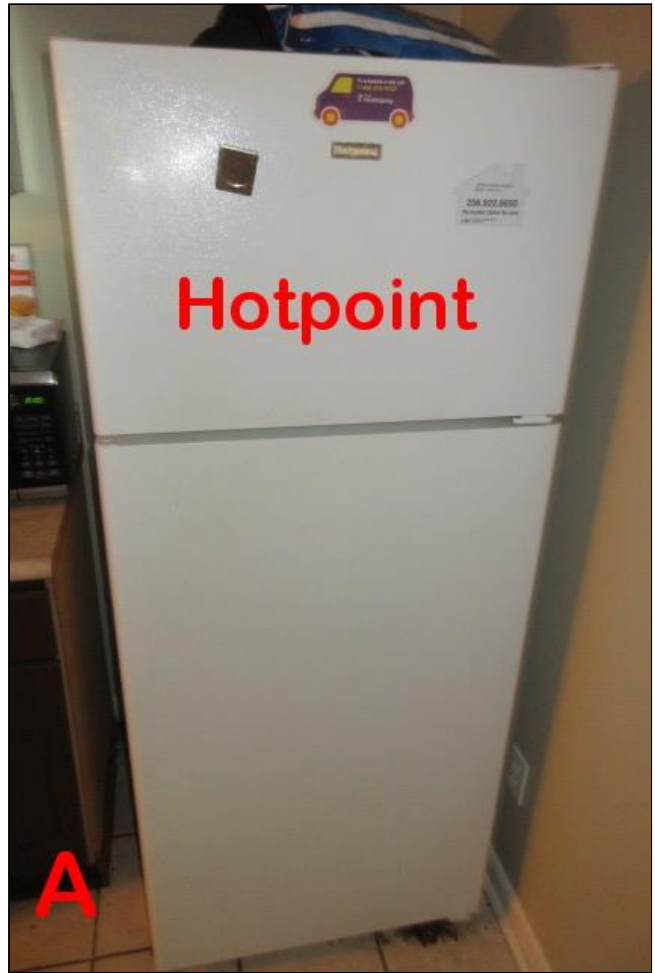
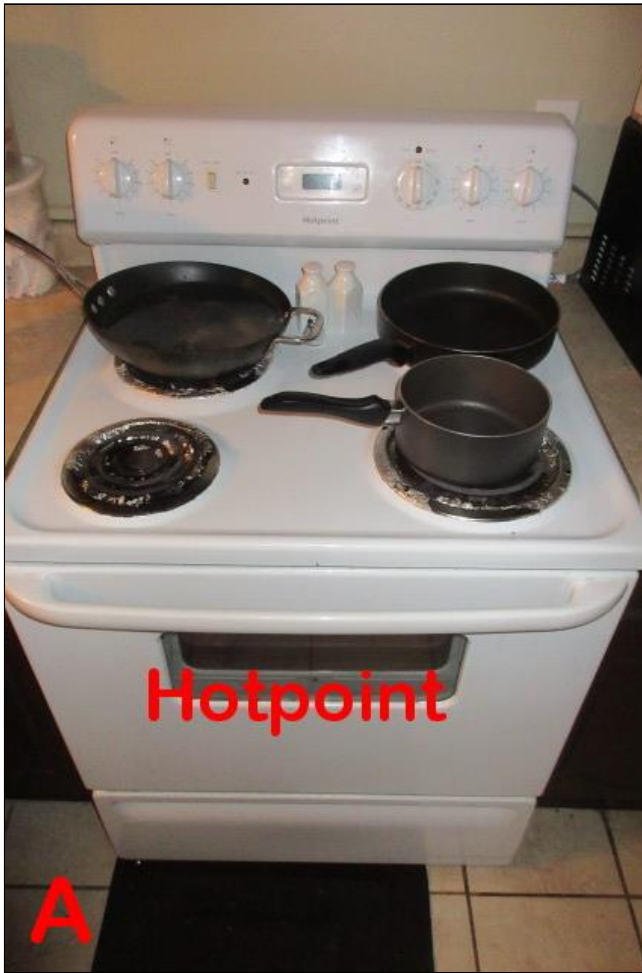
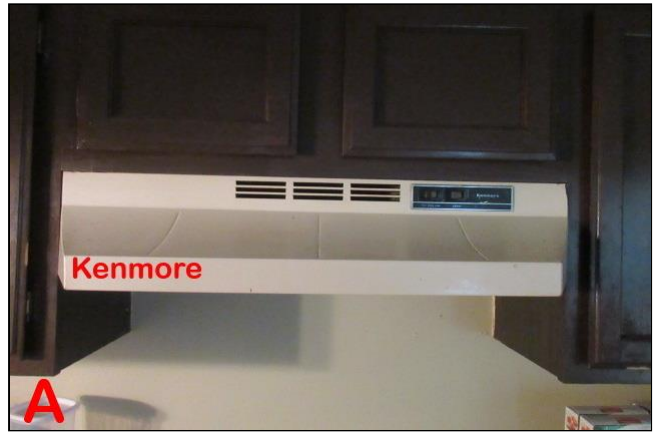
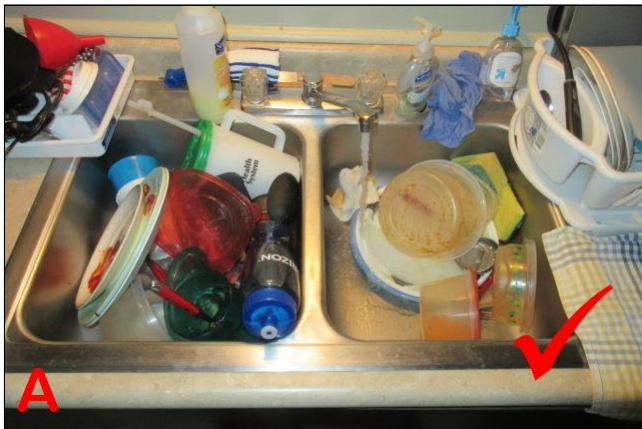
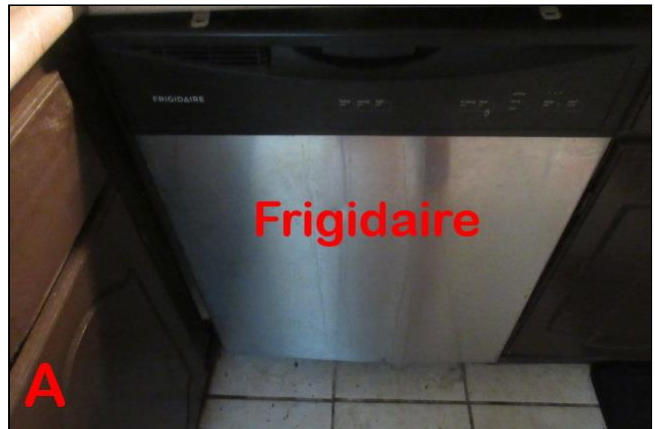
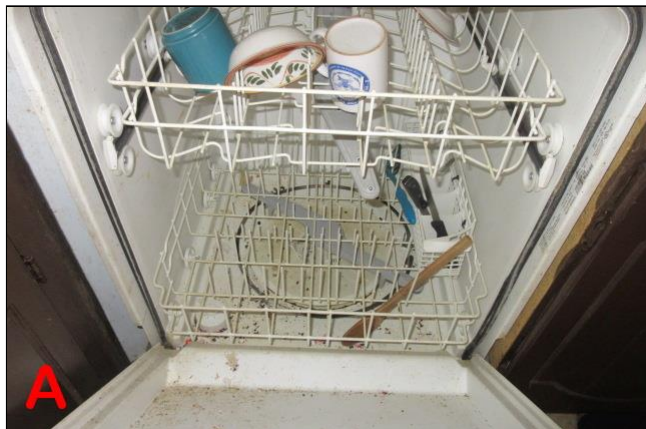
1. The anti-tip bracket is missing on the kitchen stove in all four units. This is an issue and it needs to be corrected.
2. The kitchen in unit B is in total disarray. Unable to verify that any appliance operated properly.
3. In unit D the kitchen stove did not operate at time of inspection. This is an issue and it needs to be addressed.
4. The dishwasher in unit D did not operate at time of inspection. This is an issue and it needs to be corrected.
5. Dishwasher did not operate in unit C. This is an issue and it needs to be corrected.
6. In unit A the dishwasher did not operate properly at time of inspection. This is an issue and it needs to be corrected.

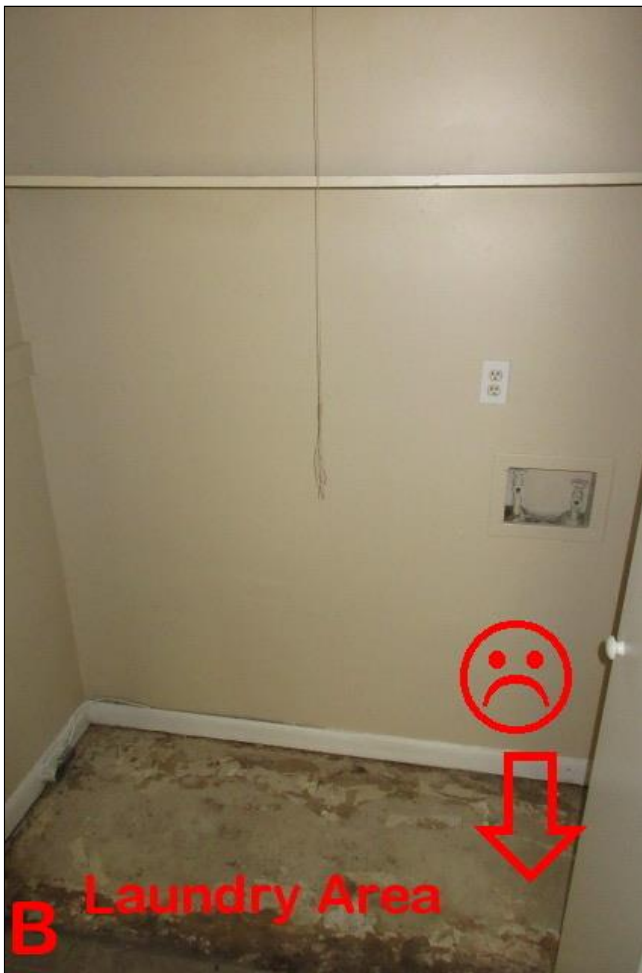
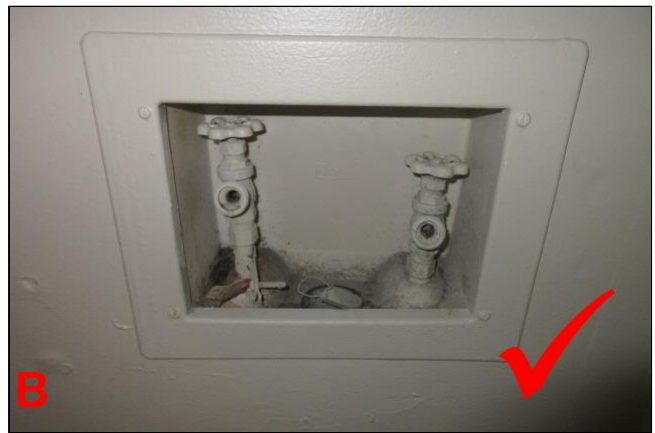
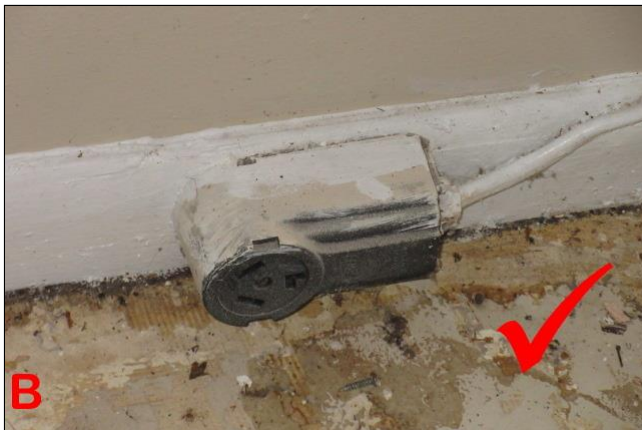
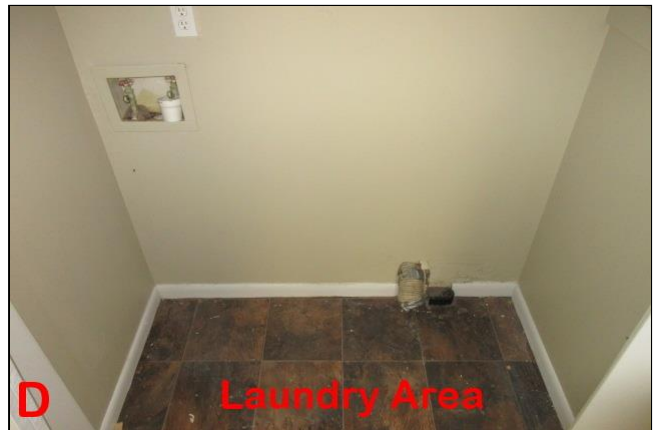
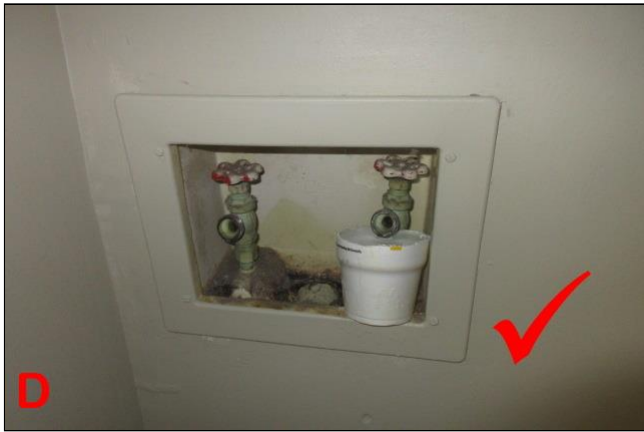
1. The laundry room in unit B is missing the dryer vent access. This is an issue and it needs to be corrected.

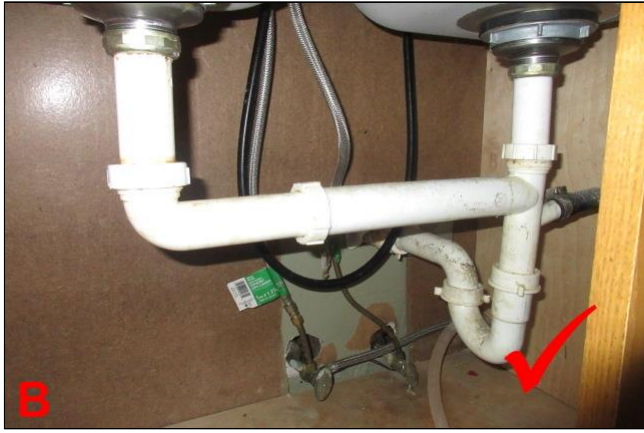
9.0 Item 1(Picture)

1. Water meter is leaking at the shut off valve on units B & D. This is an issue and it needs to be corrected.
2. In unit D the pressure relief valve plumbing on the water heater is missing. This is an issue and it needs to be corrected.
3. Accordion style plumbing drain line is not proper plumbing material. In unit D. This is an issue and it needs to be corrected.

Every plumbing leak should be examined by a qualified repairman, and every leak should be repaired immediately regardless of the nature or size of the leak. (I have never seen a large leak get smaller, or a small leak disappear)

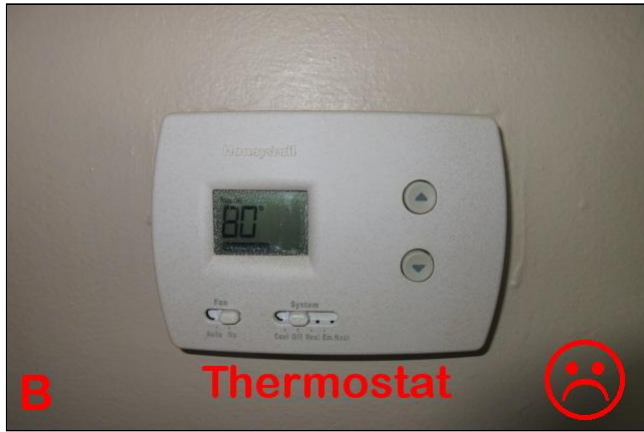
10.0 Item 7(Picture)

Thermostat
